Manhole Inspection Summary

Manhole # S39W__008MH

Insp Date: **8/12/09 2:47 PM**

Location Address: **1841 Ludlow Dr**

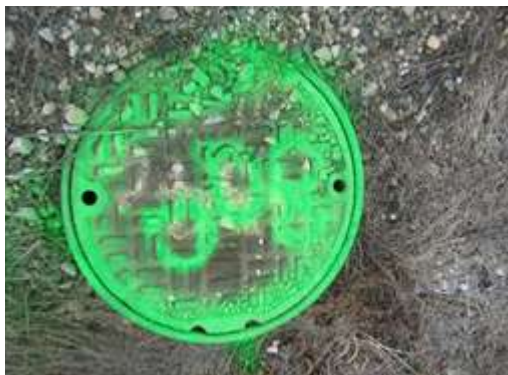
Miscellaneous

mh cover

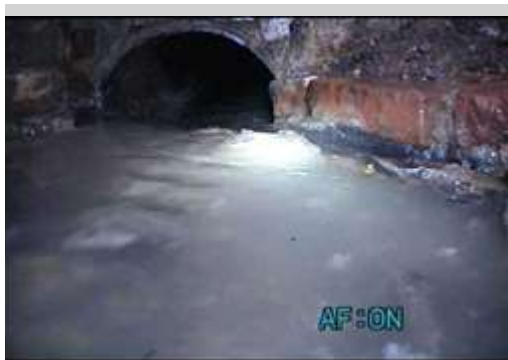
Defect 1

Condition: ☐ Sound ☐ Cracked ☐ Root Intrusion ☐ Deteriorated ☐ Leaks ☒ **Debris**

debris in channel

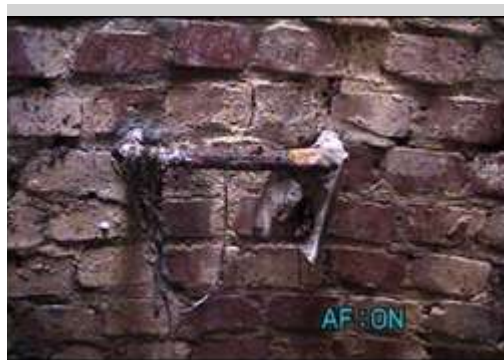
Defect 4

Steps Count: **5** Missing: **0** ☒ **Corroded**

Surcharge ☒ **Evidence Of Surcharge** Depth: **3** (ft.) ☐ Active Surcharge Present

evidence of surcharge @ 3ft; corroded steps

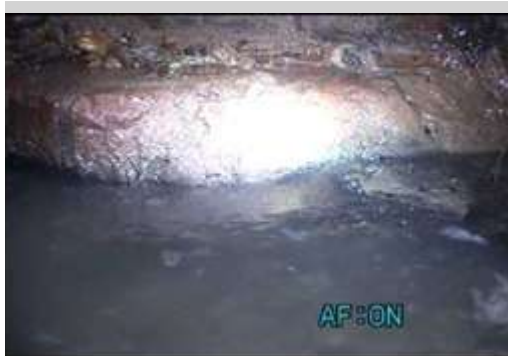
Defect 2

Condition: ☐ Sound ☐ Cracked ☐ Root Intrusion ☒ **Deteriorated** ☐ Leaks ☐ Debris

bench deterioration

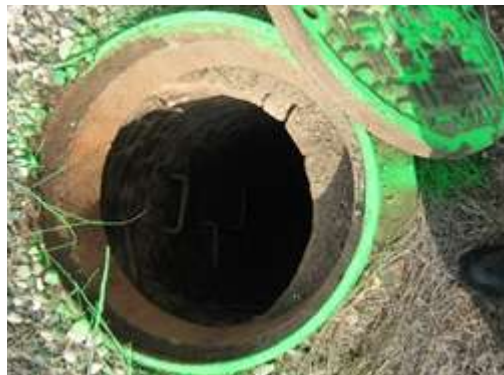
Defect 5

Frame Offset: **4** (in.) Condition: ☒ Sound ☐ Cracked ☐ Leaks

frame offset

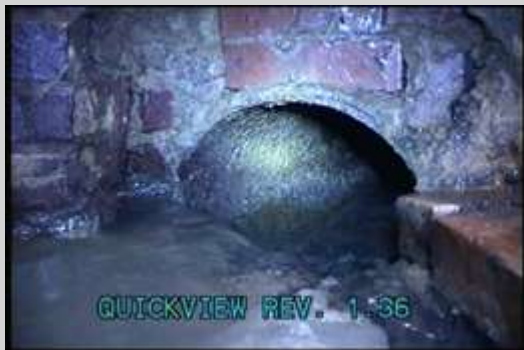
12 O'Clock Outflow

12 in. Circular Gravity Sewer
Pipe Out @ 12 O'Clock

Pipe Height: **12** (in.) Rod and Bar (Angled)
Pipe Material: **Clay** ☐ Pipe Lined
Invert Depth: **11.30** (ft.) Flow Characteristics: **Slow**
Deposits: ☒ None ☐ Mud ☐ Sludge ☐ Debris ☐ Grease
Silt Depth: **0** (in.) Deposits Extent:
Infiltration: **None** Pipe Seal Cond: **Sound**

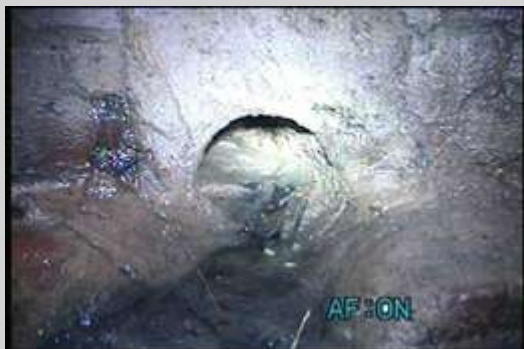
6 O'Clock Inflow

6 in. Circular Gravity Sewer
Pipe In @ 6 O'Clock

Pipe Height: **6** (in.) Rod and Bar (Angled)
Pipe Material: **Clay** ☐ Pipe Lined
Invert Depth: **10.68** (ft.) Flow Characteristics: **Slow**
Deposits: ☒ None ☐ Mud ☐ Sludge ☐ Debris ☐ Grease
Silt Depth: **0** (in.) Deposits Extent:
Infiltration: **None** Pipe Seal Cond: **Sound**

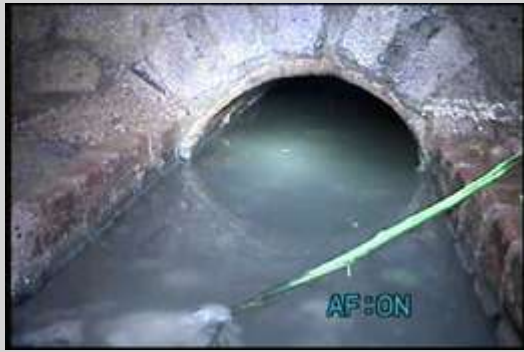
8 O'Clock Inflow

10 in. Circular Gravity Sewer
Pipe In @ 8 O'Clock

Pipe Height: **10.8** (in.) Rod and Bar (Angled)
